Unit 21

Embedded Failures

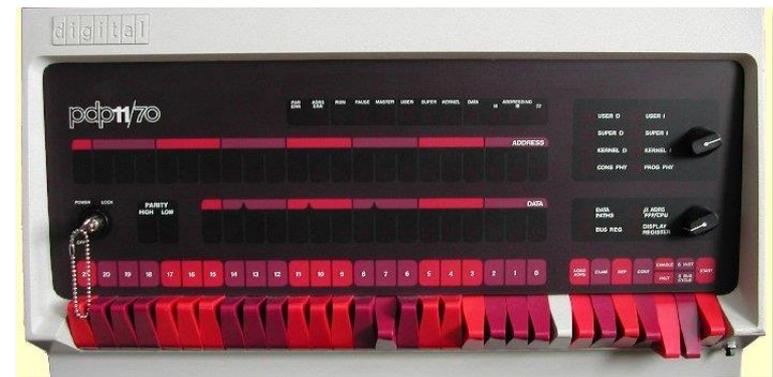
- The Therac-25 was a medical radiation therapy machine developed in Canada in the mid-1980s.
- Controlled by a PDP-11 (16-bit minicomputer)
- Errors in the hardware/software design led to three patients being killed and many injured.

- Examination of the system revealed numerous defects that could lead to improper operation:
 - Insufficient hardware/software interlocks to prevent dangerous types of actions.
 - Certain unusual patterns of keystrokes could put the system in the incorrect mode.
 - Software was reused from previous models despite changes in the overall design.
 - No way for software to tell if the hardware was doing what it was told to do (open loop control).
 - Control tasks and operator tasks were not synchronized leading to possible race condition.
 - Overflows in some variables were not detected.

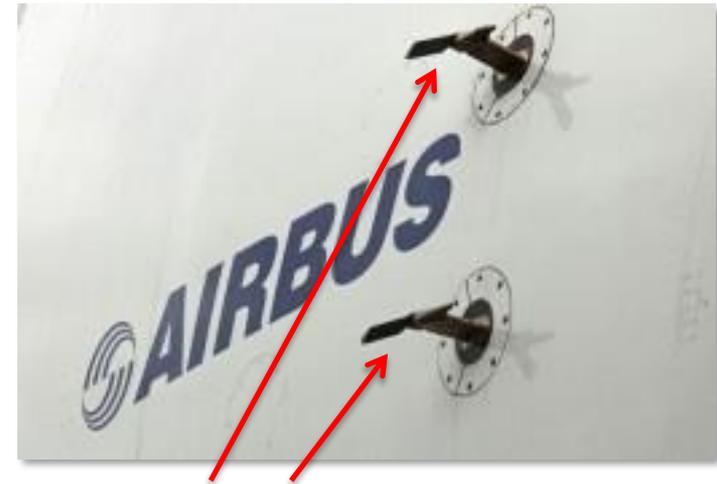
Pitot tubes

- Aircraft encountered icing conditions that caused ice crystals to clog the sensors that measure air speed.
- With no air speed data, the autopilot disengaged and pilots took manual control of the aircraft.
- Pilots were not experienced in flying without the autopilot under these conditions and did several things wrong.

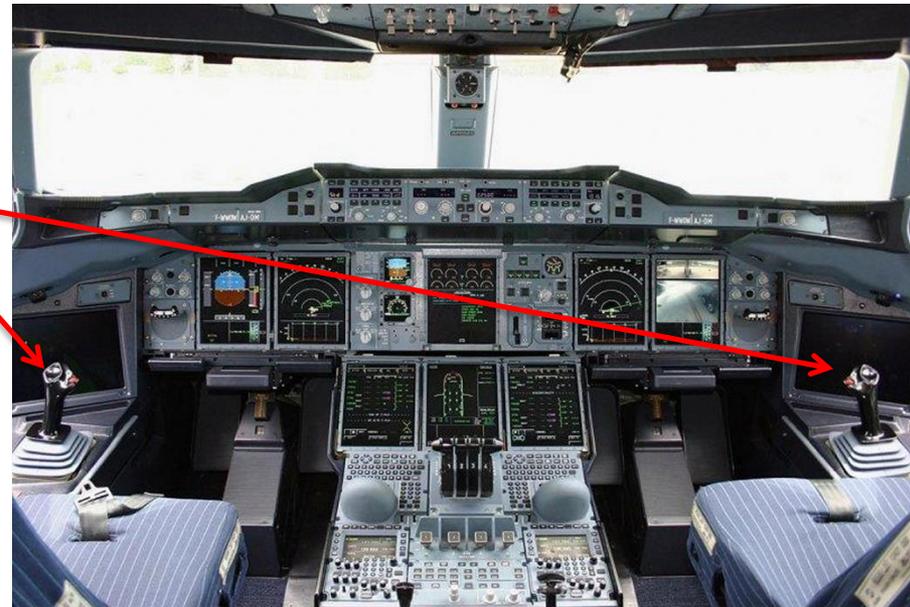
AirBus A330 cockpit

- Plane entered a severe nose-up configuration leading to a stall condition.
- Pilots were given confusing information from the instruments and did not correct the situation.

Control sticks

- Pilot and copilot both had control sticks.
- Software would combine the position information from both and control the plane on that basis.
- During the flight the pilot was pushing his stick forward to bring the nose down but the copilot was pulling his back.
- No mechanical connection between the two control sticks.

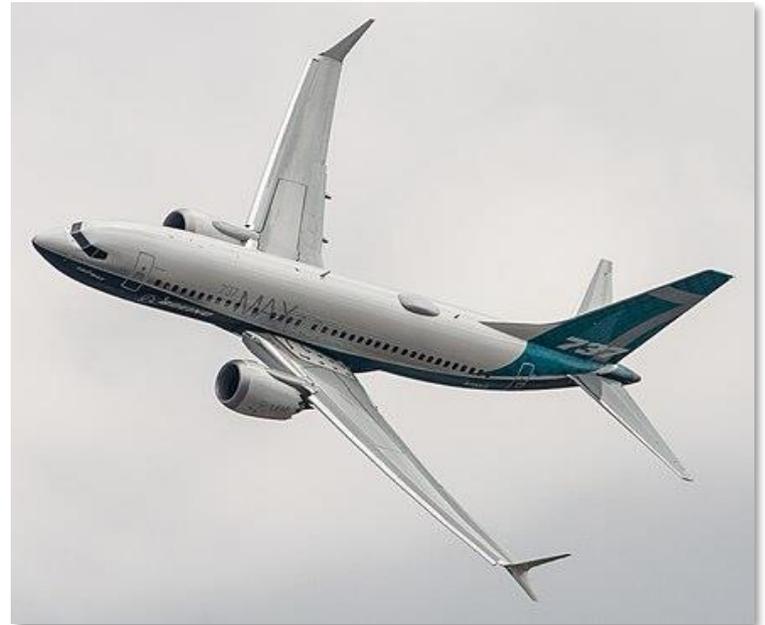
Boeing 737 MAX

- The 737 MAX is an update of their best-selling airliner.
- New engines used for better performance, but were larger and had to be mounted differently, and this would cause changes in the handling in the air.
- Redesigning and recertifying the 737 was expensive so Boeing tried to compensate for the altered handling in the flight control software.

- With engines more forward and higher, plane tended to nose-up at times.
- **Maneuvering Characteristics Augmentation System (MCAS)** flight control software was designed to compensate by adjusting the horizontal stabilizer.
- Two crashes in Indonesia (2018) and Ethiopia (2019) killed 346 people and were determined to be caused by MCAS.
- Grounded worldwide from March 2019 to November 2020.
